# **Intel<sup>®</sup> Pentium<sup>®</sup> III Xeon<sup>™</sup> Processor Specification Update**

Release Date: April 2000

Order Number: 244460-013

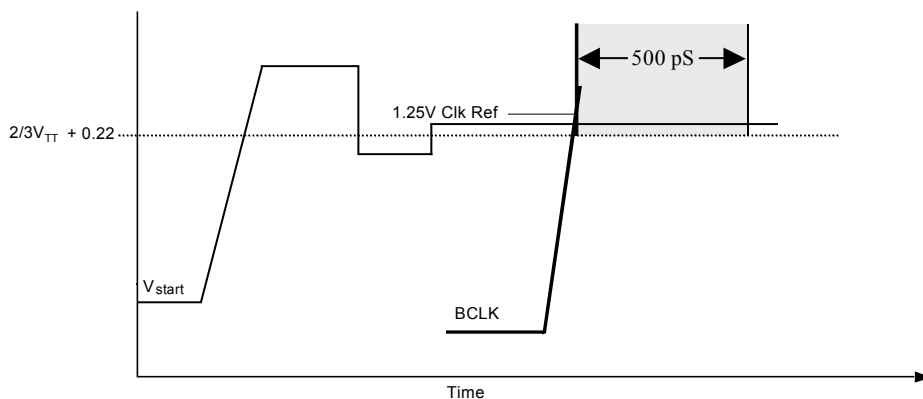
The published AGTL+ AC specification for  $V_{IH(MIN)}$  is  $(2/3 \cdot V_{TT}) + 0.1$  Volts.

Intel has characterized the new AGTL+ AC specification for  $V_{IH(MIN)}$  on the processor's RS0# signal to be:  $(2/3 \cdot V_{TT}) + 0.22$  Volts within 500 picoseconds following the rising edge of BCLK crossing the 1.25-Volt threshold. See below.

**Implication:** The deviation from the published specification results in decreased noise margin on the RS0# processor input. This decreased noise margin has been observed to be particularly detrimental in system environments where the RS0# processor input is being driven by an I/O buffer with a pull-up device (such as a p-channel transistor) that is switched off mid-cycle. Systems that employ I/O buffers that keep the pull-up device on for the entire cycle are significantly less affected by this erratum. The reduction in noise margin may lead to the generation of BINIT# (when enabled) resulting in a system reset, otherwise this condition may lead to a system "hang" condition.

**Workaround:** If a system design cannot meet the specification deviation, the following areas should be carefully examined to assure that additional margin exists in order to compensate for any deficit observed with respect to the newly characterized  $V_{IH(MIN)}$  specification:
